CHURCH OF THE HOLY SEPULCHRE JERUSALEM

STRUCTURAL SURVEY
FINAL REPORT

WILLIAM HARVEY

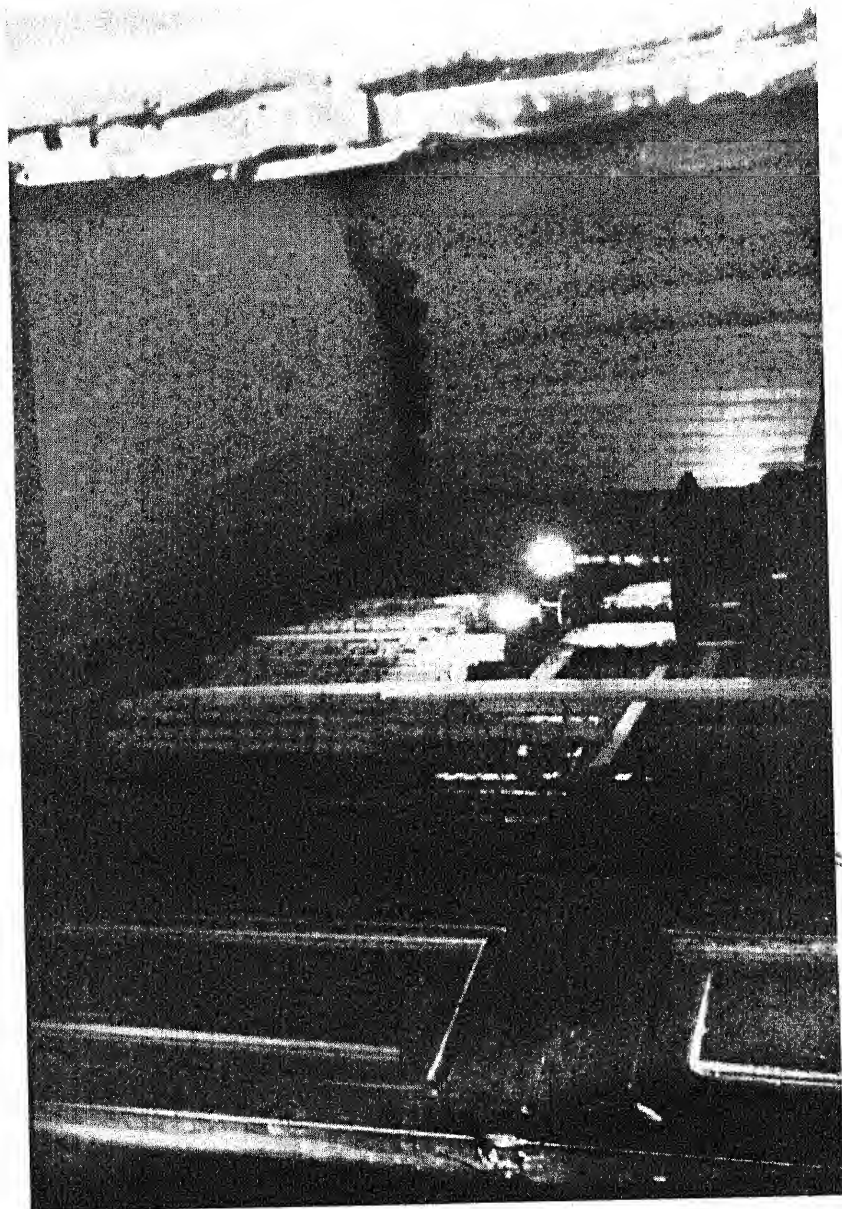
produce another such conflagration. Many of the small rooms which have been formed in the aisle of the Rotunda (see Figs. 72, I, 23) are used as stores for miscellaneous property, including large quantities of candles and oil. As there is much dry and decaying timber adjacent, a fire could easily be started, especially as only open lamps and candles are used for light in these rooms.

FIG. 72. CANDLE STORE IN OLD AISLE OF ROTUNDA

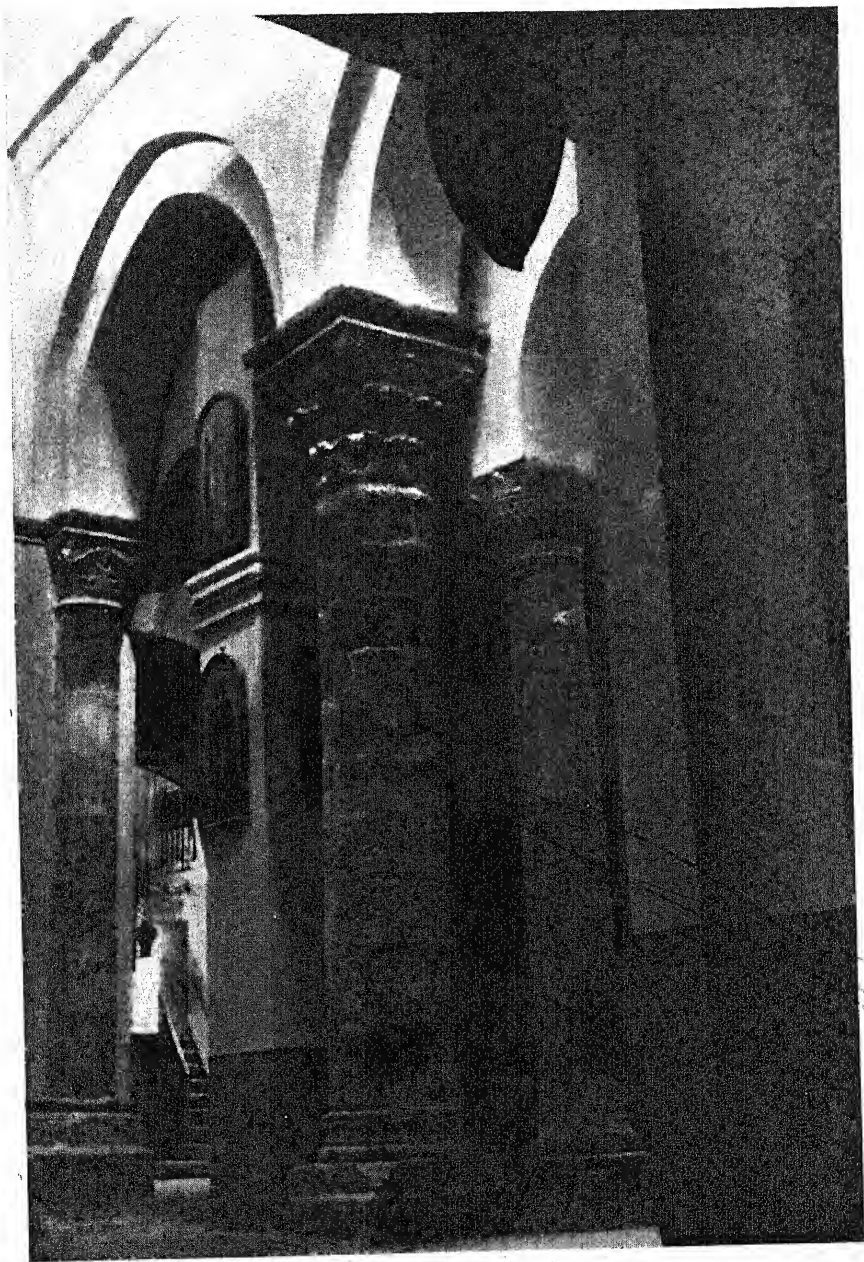
FIG. 73. PIERS OF NORTH TRANSEPT, SHOWING
MASONRY AND PLASTERED FACES

(1) An alteration which would affect the whole Church, though without changing the present arrangement, would be the stripping off of all plasterwork, thus revealing the original stone faces, which would then be carefully washed. As very large portions of the plasterwork would in any case be removed during the work of repair, this would involve little extra labour, and would greatly improve the appearance of the interior. Special care would have to be taken to ensure that any traces of original mosaic or colouring would be preserved (see Figs. 73, 74, 75).

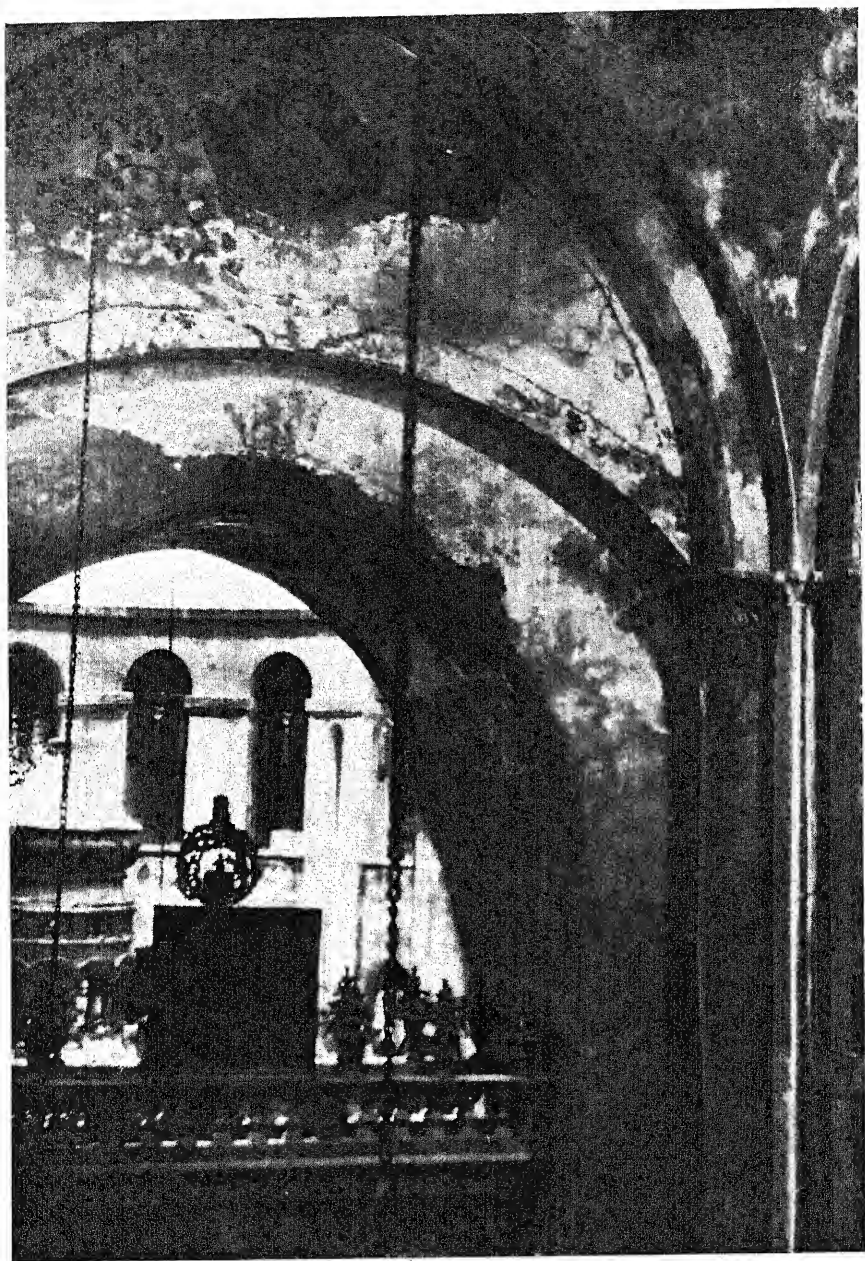
FIG. 74. GREAT ARCH OF ROTUNDA, SHOWING PLASTERING
OF 1810 CONCEALING CARVED WORK

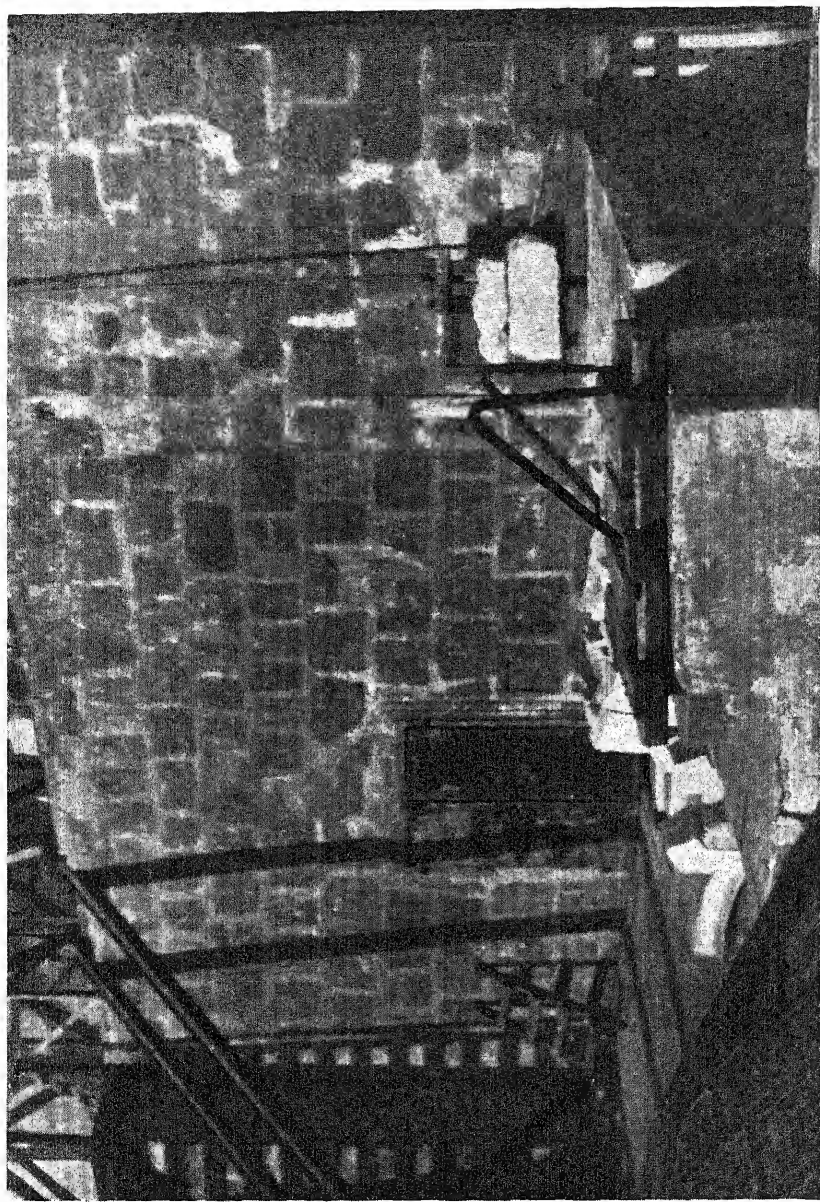
FIG. 76. WINDOW BLOCKED BY IRON DOORS

1. High vault North Transept West wall (1).
2. High vault East arm South wall (1) (see Fig. 76).
3. Ambulatory North-east apsidal chapel (2) (see Fig. 77).
4. Ambulatory centre apsidal chapel (3) (see Fig. 78).
5. Above stair to St. Helena's Chapel (1).
6. Ambulatory South-east apsidal chapel (2).

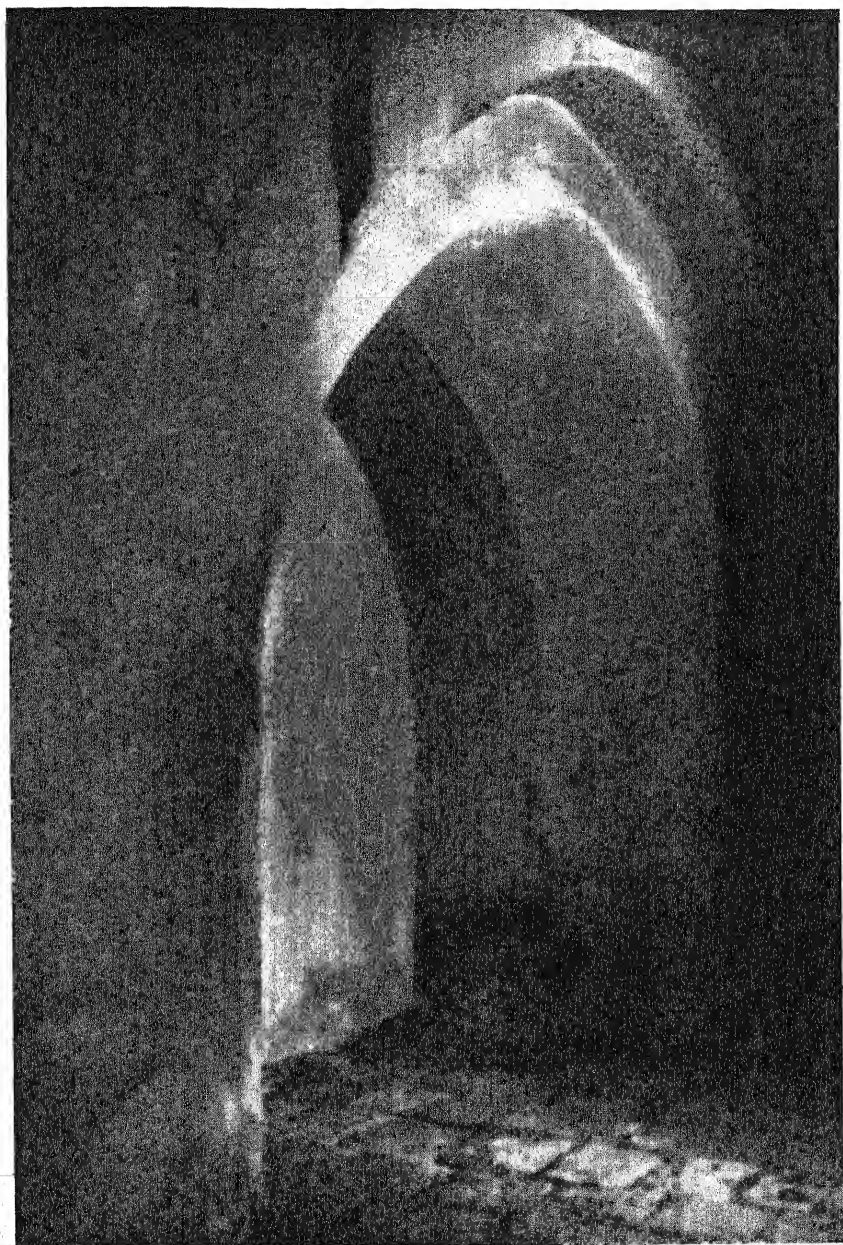
FIG. 77. BLOCKED WINDOW OF AMBULATORY

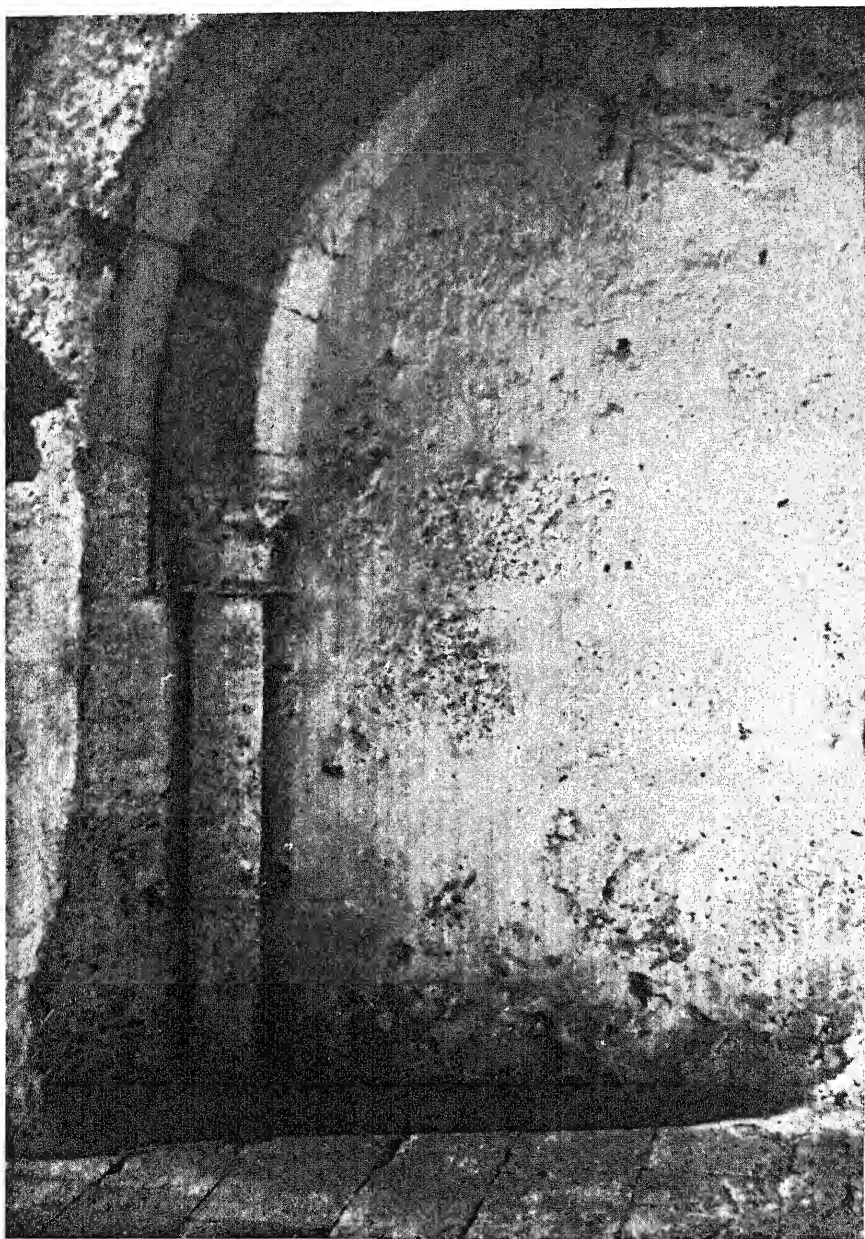
FIG. 78. BLOCKED WINDOW OF CENTRAL APSE CHAPEL

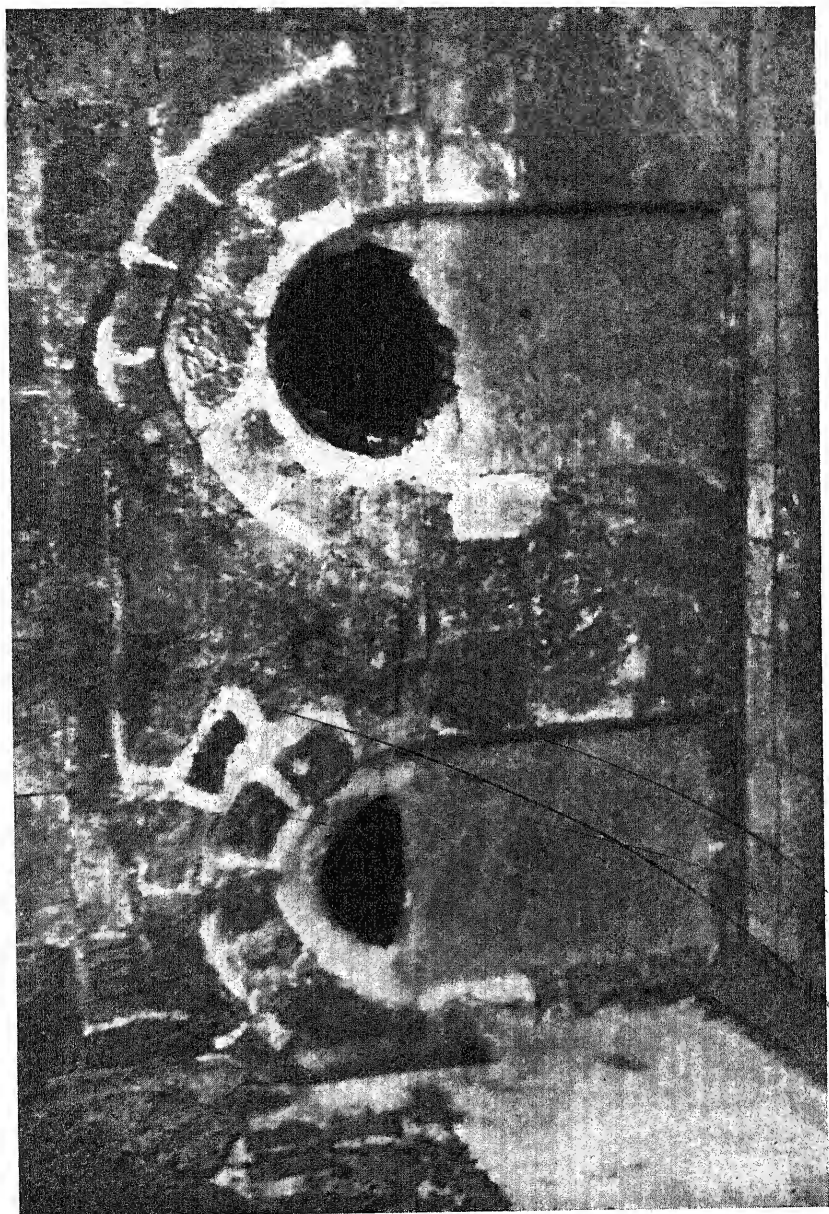
FIG. 79. PARTIALLY BLOCKED WINDOWS OF NORTH TRANSEPT

1. High vault North Transept North wall (2) (see Fig. 79).
2. High vault East arm North wall (1).
3. Eastern arm North wall—to Latin chamber (shuttered) (2).

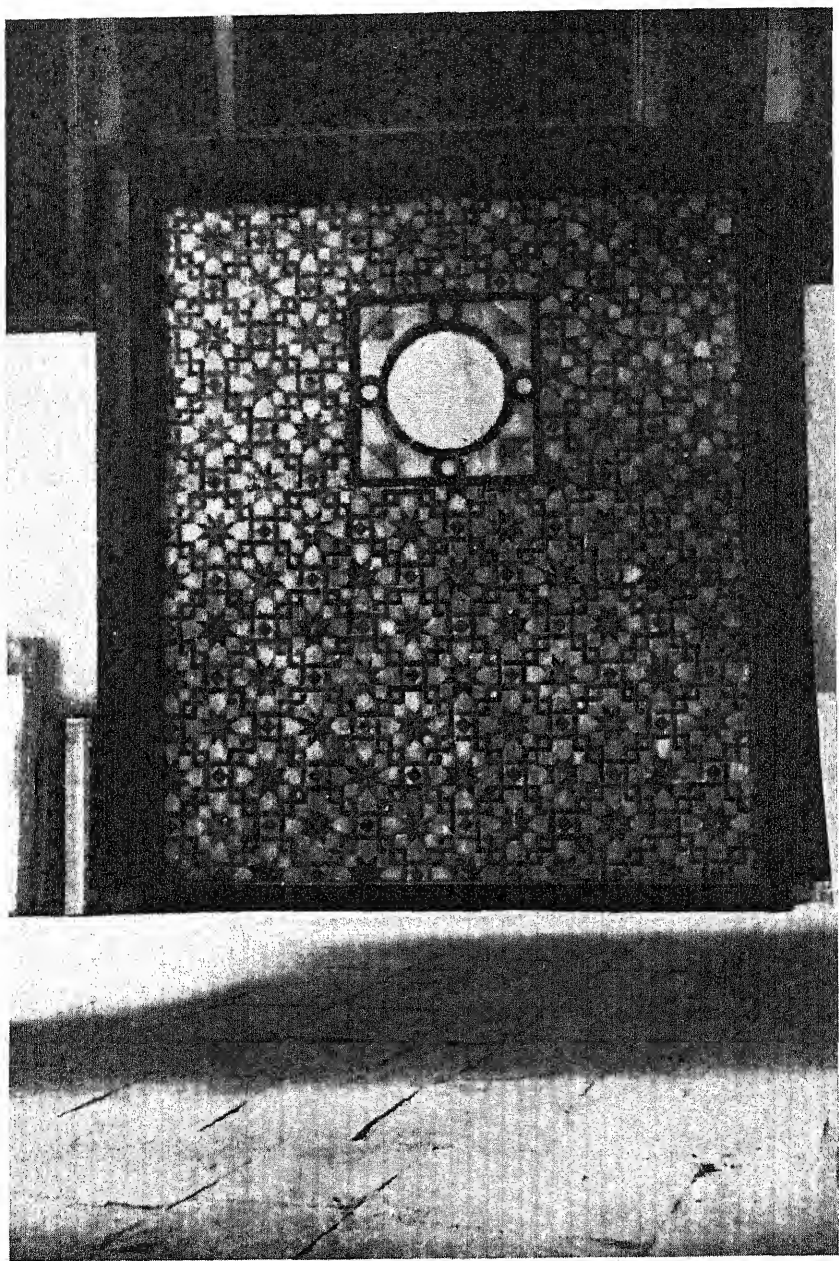
FIG. 80. PAVEMENT REMOVED FROM CHAPEL OF APPARITION

1. Chapel of the Apparition (see Fig. I, 14). The new marble slabs should be taken up, and the original mosaic reinserted. (The original is at present in the Latin gallery of the Rotunda.) (See Fig. 80.)
2. Chapel of the Franks (see Fig. I, 44) (Chapel of Our Lady of the Seven Sorrows). This original pavement requires very careful resetting, and the insertion of a few small fragments (see Fig. 81).
3. Latin Calvary Chapel (see Fig. I, 43). This pavement contains much original work, which should be reset.

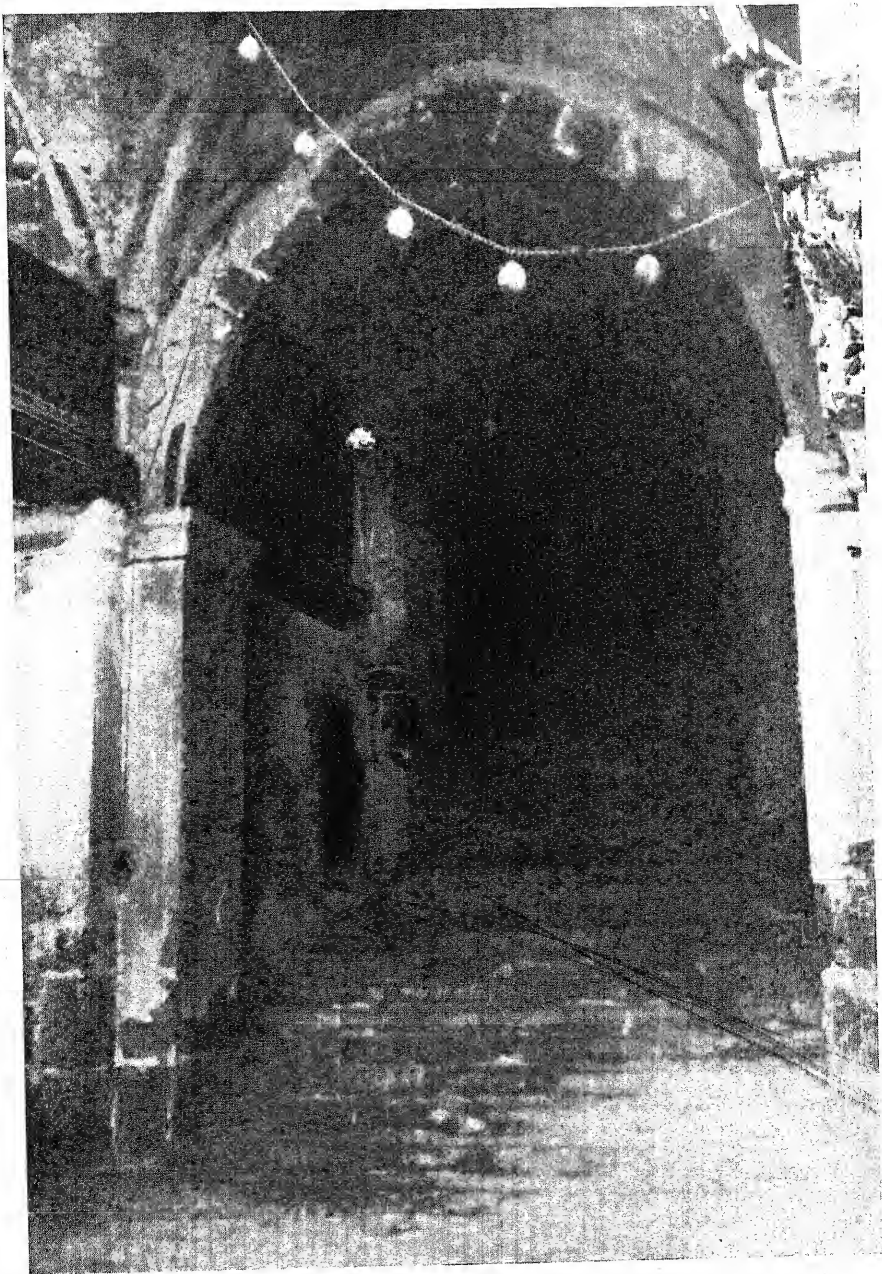
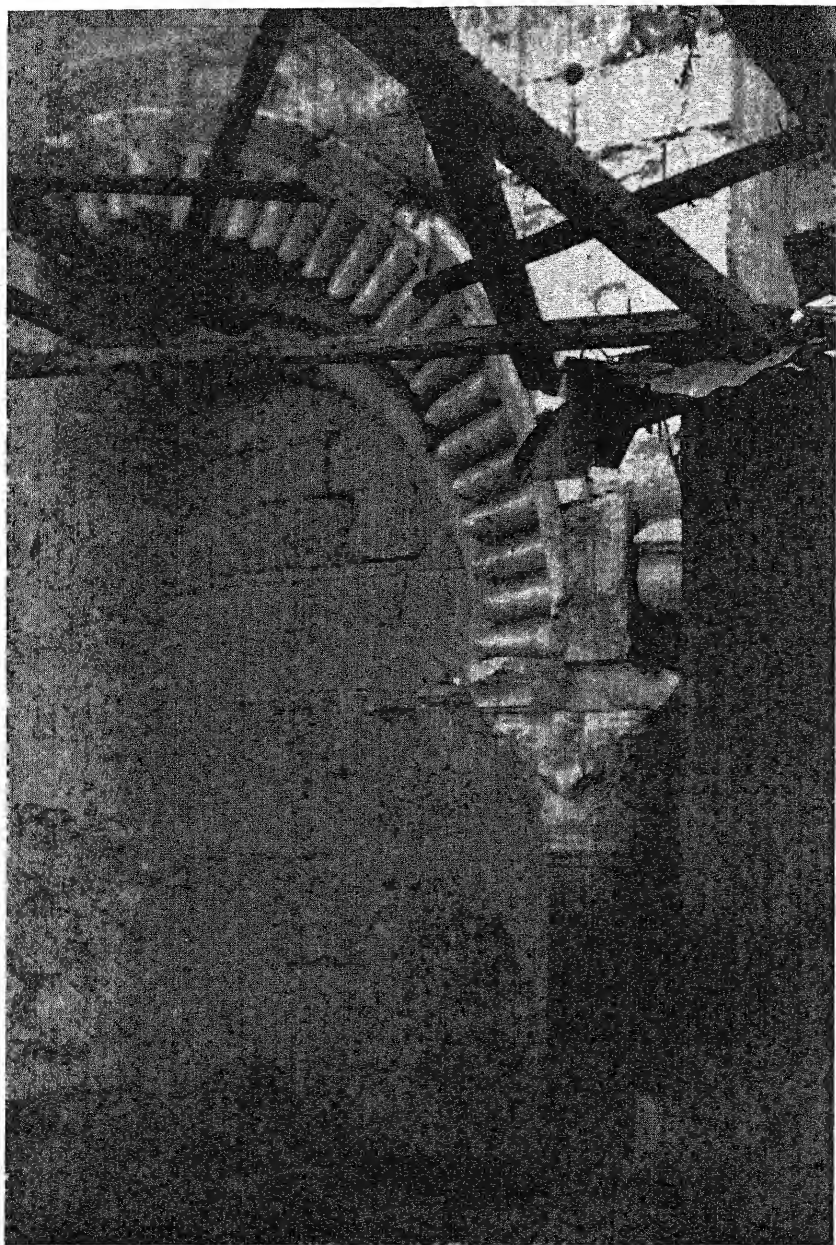
FIG. 96 ST. HELENA'S CHAPEL. NORTH-WEST BAY

FIG. 97. STAIRS FROM ST. HELENA'S CHAPEL

(13) Removal of the present partitions and wooden galleries from the western bays of the Chapel of St. Helena (see Figs. 96, 97, I, 28).

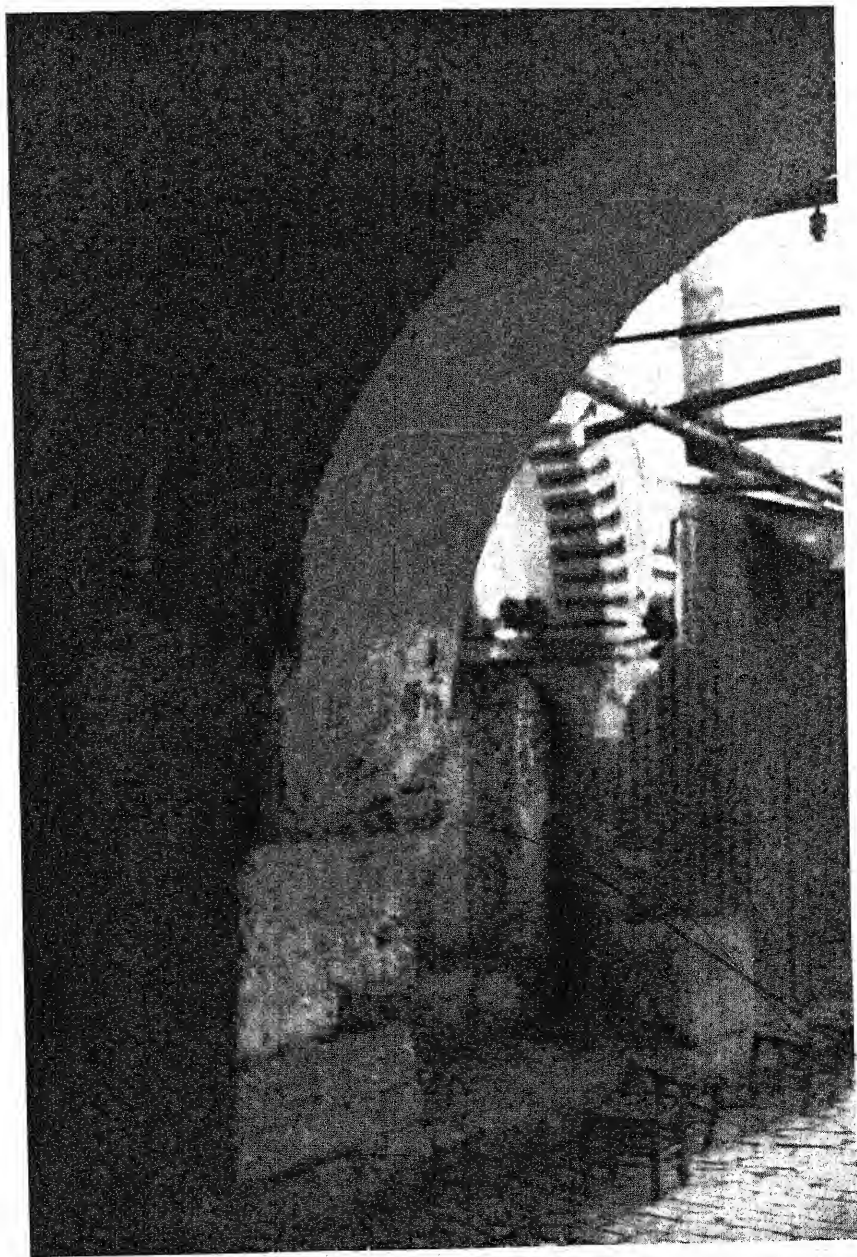
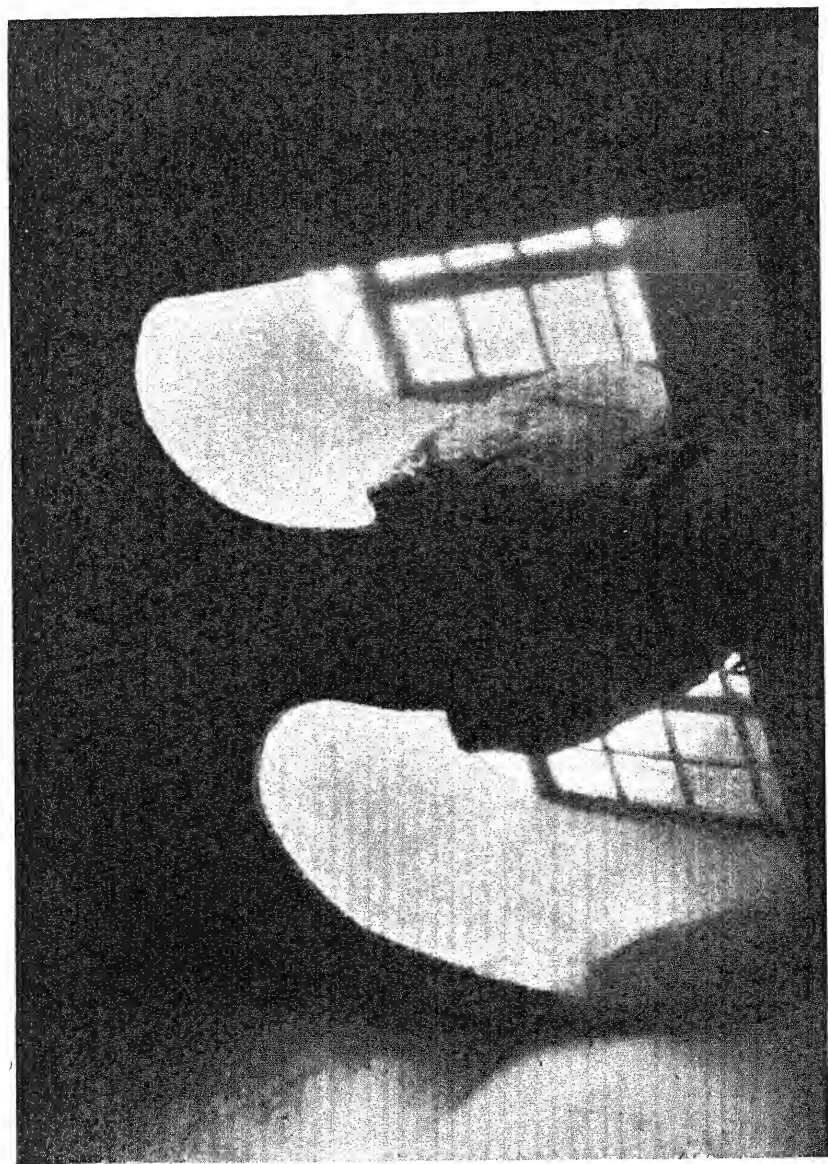
FIG. 98. ST. MARY'S GATE, CHRISTIAN STREET

FIG. 99. ST. MARY'S GATE

(14) Reopening of original St. Mary's Door in Christian Street, as an entrance to the Church, communicating with the passage to the North apse of the Rotunda. This would necessitate certain alterations in the piers supporting the vault over Christian Street (see Figs. 98, 99, I, 22).

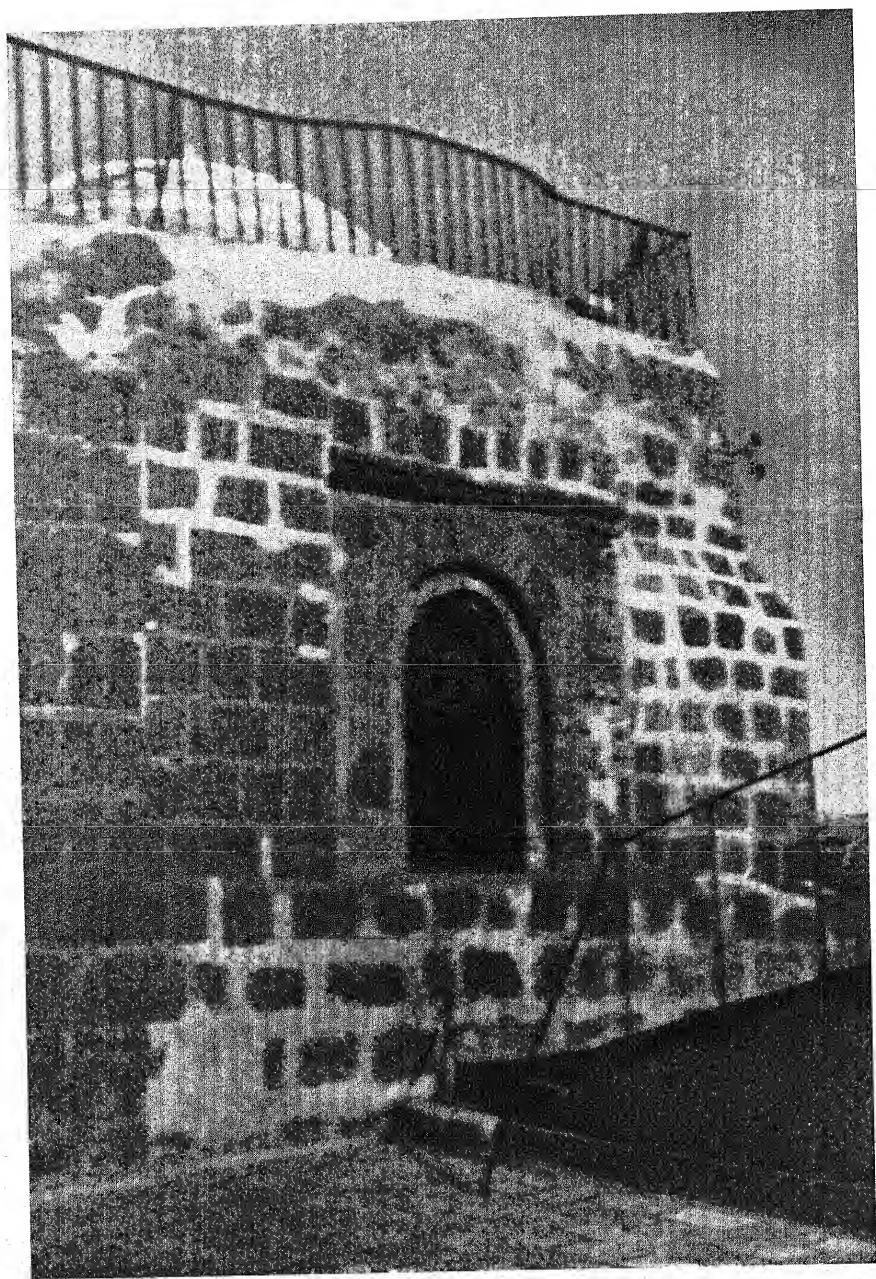
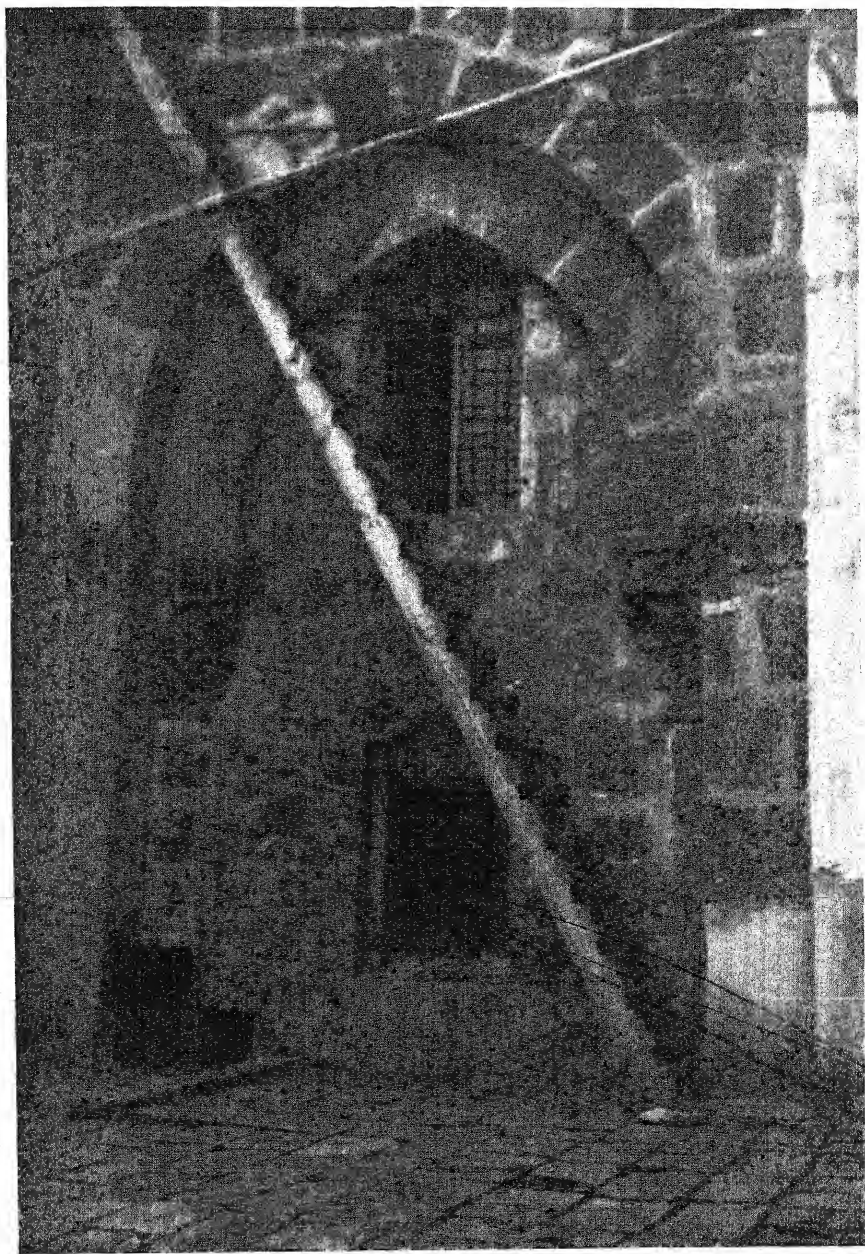
FIG. 103. SOUTH-EASTERN ANGLE OF BUILDINGS

FIG. 104. BYZANTINE OCTAGONAL CUPOLA

(18) Removal of modern accretion from beneath Byzantine octagonal cupola to east of Chapel of Melchizedek, and opening of old window in its South-east wall (see Figs. 103, 104, II, 12).

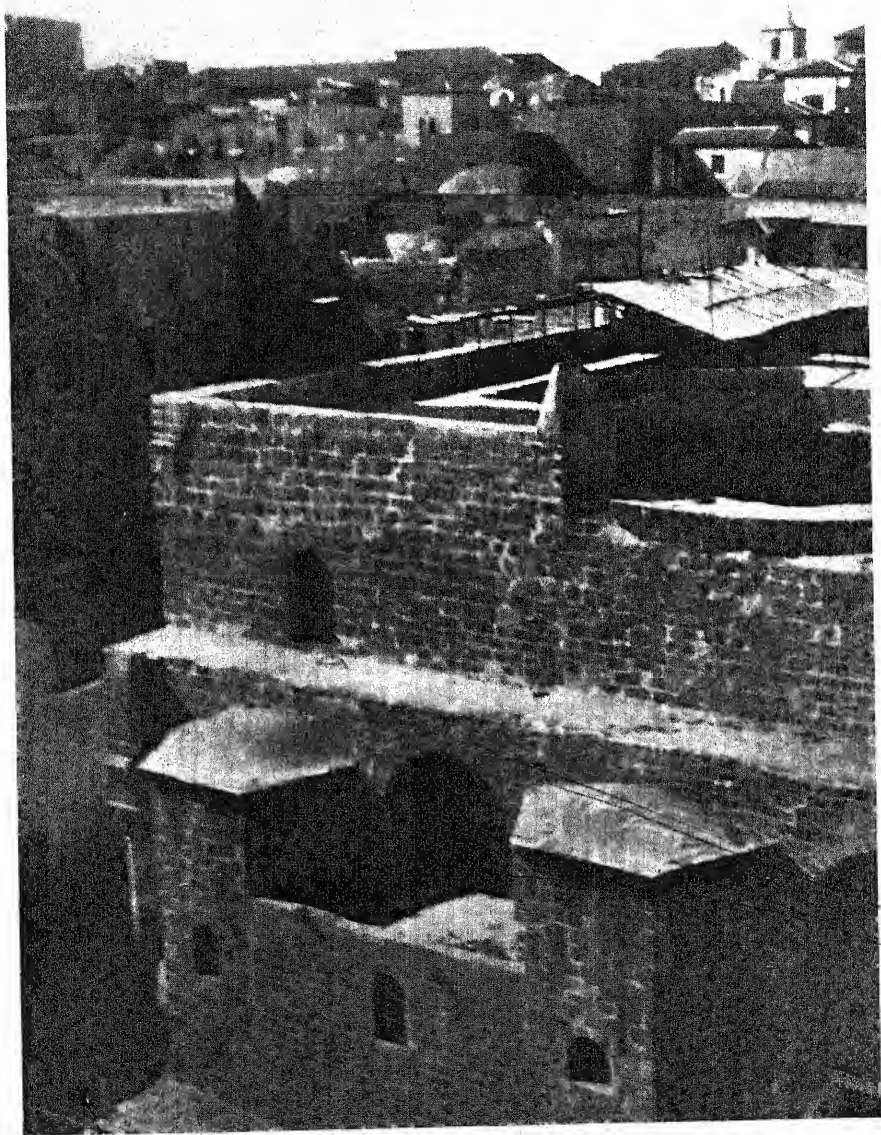
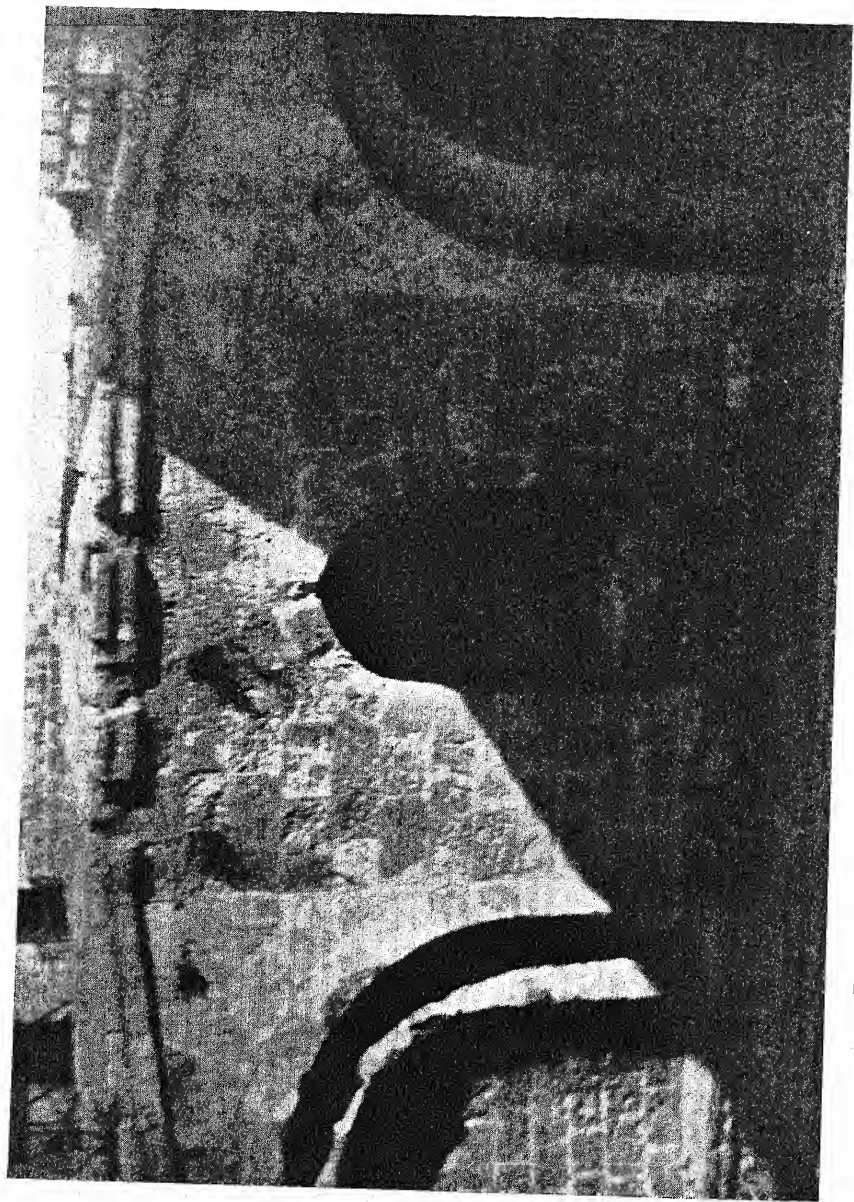
FIG. 115. OLD BAPTISTERY, ETC., FROM ABOVE

FIG. 116. EAST WALL OF OLD BAPTISTERY FROM WITHIN

(2) The rebuilding of the dome over the old Baptistery south of the Tower, and the subsequent removal of the lower vault which partially covers the space at present; also the opening of the blocked window in the eastern face (see Figs. 115, 116, I, 32-II, 19).

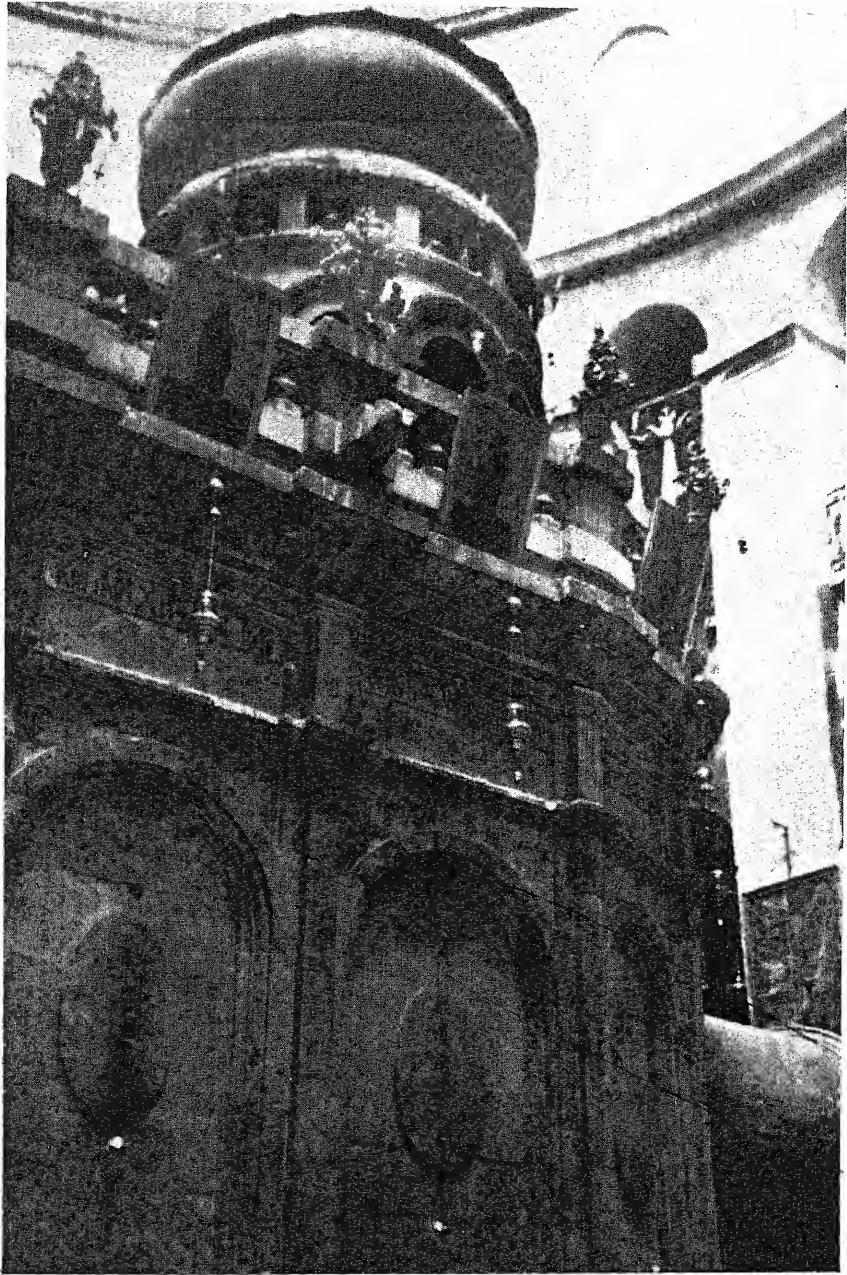
FIG. 119. THE EDICULE OF THE SEPULCHRE

As the edicule of the Sepulchre itself does not form part of the fabric, it has not been mentioned in the body of this report. Its state is, however, one of serious decay, and steps should be taken to secure it from sudden collapse.

It seems very doubtful whether its age is sufficient to justify its retention in the event of extensive repair or alternative demolition being in question. Its design (see Fig. 119) is completely out of keeping with the original Church, and would appear still more so if the suggested alterations take place, restoring to the building as far as possible its earlier form.

If it is decided to rebuild the edicule, it should preferably be designed in accordance with the existing drawings of the earlier structure which lasted from the early sixteenth century to the fire of 1808. These drawings, prepared by Bernardino Amico at the end of the sixteenth century, are to scale, and give complete details of its design. It would therefore be possible to restore to the monument a central feature in harmony with the whole.
